## Geological hazard for several cultural monuments in Albania and Bulgaria

*Margarita Matova<sup>1</sup>, Shyqyri Aliaj<sup>2</sup>*

**Key words:** faults, seismicity, slope processes, monuments

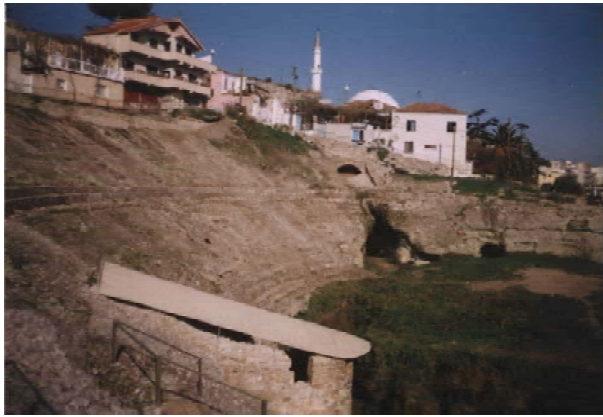
Fig. 1. The fractured Roman Amphitheater of Durres (1<sup>st</sup>—4<sup>th</sup> centuries A.D.)

The Amphitheater is placed in a segment of the contact of the Adria Plate with the Euro-Asian Plate. Many longitudinal (NW-SE) faults and some (NE-SW) ones cut the Adriatic coast. In the Durres area the longitudinal faults are better represented. The 345 Durres earthquake caused destructions in the locality. The 1926 Durres earthquake (M=6.2) provoked also destructive effects. The Amphitheater was built on Pliocene siltstone deposits. It received a number of fractures. The fractures are concentrated mainly in the western part of the construction. They cut the basement as well. In the western part of the Amphitheater the configuration of the hill per-

mits the development of slope processes, mainly landslides. The main deformation of the Amphitheater is as a result of the faults, seismic events and the activation of the slope processes (fig. 1). Now the construction is partially subsided as a result of earthquakes and landslides.

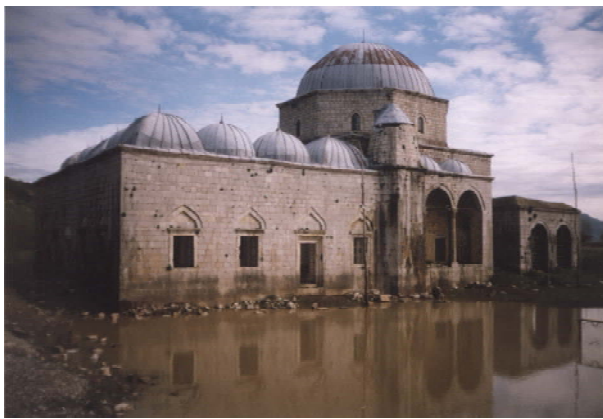
Fig. 2. The subsided and flooded Lead Mosque of Shkodra (18<sup>th</sup> century)

The Lead Mosque of the town of Shkodra (18<sup>th</sup> century A.D.) is situated on the Northern Albanian Adriatic coast. The construction was very representative and heavy (fig. 2). It is in close vicinity with the Adriatic Sea, the Drin River, the big Shkodra Lake and the Albanian Alps. Now the Mosque is subsided and partially flooded (fig. 2). The Mosque could not be used.

The site for the Lead Mosque is not well selected from the geological point of view. The Mosque is built on Quaternary alluvium. It is situated in a sector of the Albanian coast where the transversal faults are the most respectable. The local subsidence is a result of the significant activity of the Shkodra fault

zone (NE-SW) and several local earthquakes (fig. 2). A lot of destructive earthquakes are registered in the area. The local 1905 Shkodra earthquake ( $M=6.6$ ) and the regional one, the 1979 Albanian-Montenegro border area earthquake ( $M=6.9$ ) are among them. These seismic events caused damages in the territory of the town of Shkodra, including the Lead Mosque, and the adjacent territory.

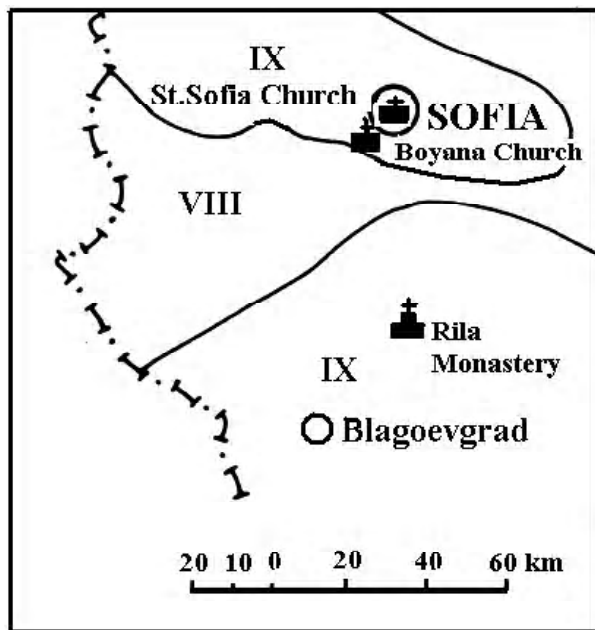
Fig. 3. Possible seismic effects in the studied Bulgarian monuments during 1000 years period (Code for Engineering Constructions in Seismic Active Areas, 1997)

St. Sofia Church is in middle part of the Sofia complex graben. The graben has Neogene-Quaternary evolution and supplementary block fragmentation. It is in a territory with high seismic hazard (fig. 3). During 1858 Sofia earthquake ( $M=6.5$ ) the seismic deformation of the graben was the most impressive (Solakov et al., 2001). It destroyed one of the mosque

minarets and killed persons. After the seismic event the transformed in mosque church was abandoned. At the beginning of the 20<sup>th</sup> century it was restored again in an Eastern Orthodox Christian Church. The destruction effects in the St. Sofia Church are related to the faulting and the block fragmentation of the Sofia graben as well as to the seismic activity of the graben territory (fig. 3).

The Boyana church was built in the Vitosha fault zone. The fault zone is recent active structure with considerable seismicity (fig. 3). Moreover, the church takes part at the foot of the northern steep slope of the Vitosha horst. It is a territory of intensive proluvial-deluvial fans development and local manifestations of slope processes. The church lies on one of these fans. There are manifestations of landslides and rockfalls along the steep mountain slope. The position of the church in a territory with intensive

The Rila Monastery was constructed in seismic hazardous region (fig. 3). There, the local earthquakes are numerous and the regional seismic events rich  $M > 7.0$ . The 1904 Kroupnik earthquake provoked partial destructions in the monastery. The construction is placed on the Quaternary sediments of the Rila River terrace. Its basements were put in the alluvial and proluvial coarse sediments, also in cultural layers. The alluvial and the proluvial sediments include intercalations of plastic clays. The monastery is situated in very close vicinity with the steep slope of Rila Mountain. The adjacent mountain slope and the lithology of the Quaternary layers permit the development of slope processes. The seismological data for the region, the local steep mountain slope and the unstable terrigenous sediments with plastic intercalations in the monastery basement cause the increase of geological vulnerability of the locality. The regional seismicity and the local slope processes create constant hazard for the monastery.
